# Manhole Inspection Summary

Manhole # S67M\_\_012MH

**Location** Address: **6430 O'Donnell St.**

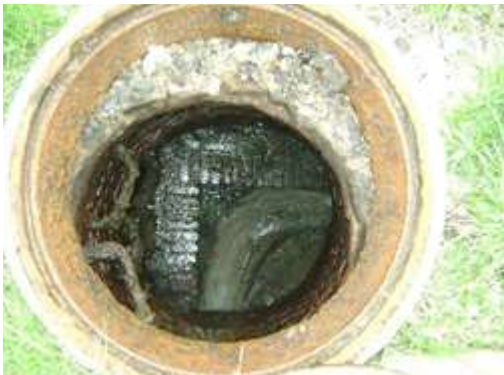
Defect 2

**Frame** Offset: **3** (in.) Condition: ☒ Sound ☐ Cracked ☐ Leaks

Frame offset defect

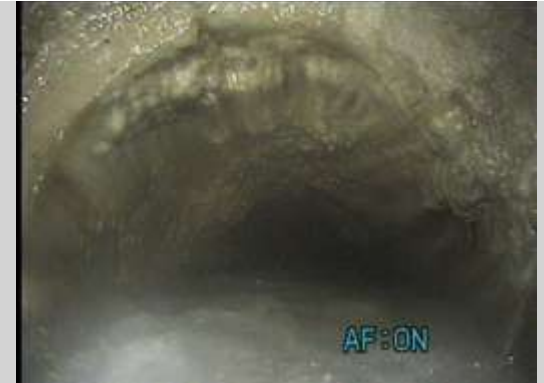
12 O'Clock Outflow

Comments **GREASE IN O-12 PIPE AND IN CHANNEL.**

Grease buildup on O-12.

Pipe Height: **10.8** (in.) Rod and Bar (Angled)  
Pipe Material: **Clay** ☐ Pipe Lined  
Invert Depth: **9.25** (ft.) Flow Characteristics: **Turbulent**  
Deposits: ☐ None ☐ Mud ☐ Sludge ☐ Debris ☒ Grease  
Silt Depth: **0.5** (in.) Deposits Extent: **Medium**  
Infiltration: **None** Pipe Seal Cond: **Sound**

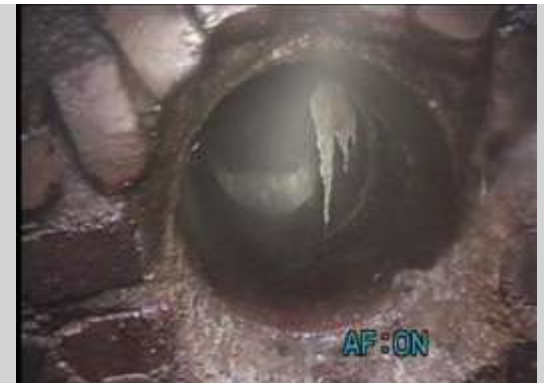
3 O'Clock Inflow

Difficult to tell if I-3 drop extension is blocked.

Drop: **Outside** Rod and Bar  
Angled: **Yes** Reading: **7.79** (ft.)  
Inv Depth: **8.79** (ft.)

Drop Condition: **Open**
